INTERNATIONAL JOURNAL OF MULTIDISCIPLINARY RESEARCH

Volume 9, Issue 4, April 2022

A Review on Blackspot Safety Assessment and Rectification

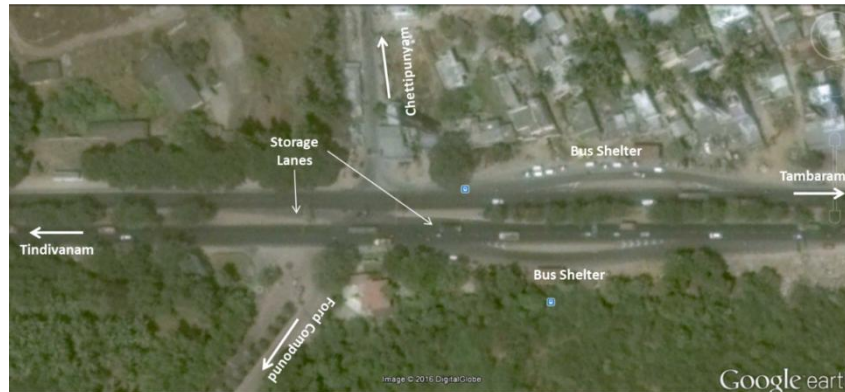
Figure 2: Identified Assessment Location on NH-45

The identified assessment location is located on NH-45, which is a four-arm junction. The main road is the national highway (NH-45) and traversing along north-south direction from Chennai to Villupuram. This is a four-lane divided carriageway with paved shoulders. As the national highway orientation is along north-south direction, the side roads are along east and west directions. A collector road coming from Mahindra World city on east side and another is intersecting from the west connects NH-45 leading to Chettipunyam, which makes the location to operate as a 4-legged junction. The identified Junction on NH-45 is shown in **Figure 2** and its latitude and longitude in Google Map are 12° 44' 34.16"N and 79° 59' 31.51"E respectively. **Figure 3** shows photograph of identified assessment area.

- Northern arm leads to Chennai/Tambaram. This facility has four lanes with divided carriageway and paved shoulders on either side;
- Southern arm leads to Tindivanam/Villupuram. This is a four lane facility with divided carriageway and paved shoulders on either side;
- Eastern arm leads to Mahindra World City. This is a four-lane facility with divided carriageway and paved shoulders on either side; and
- Western arm leads to Chettipunyam. This facility is a two lane carriageway with width of about 7.0m.

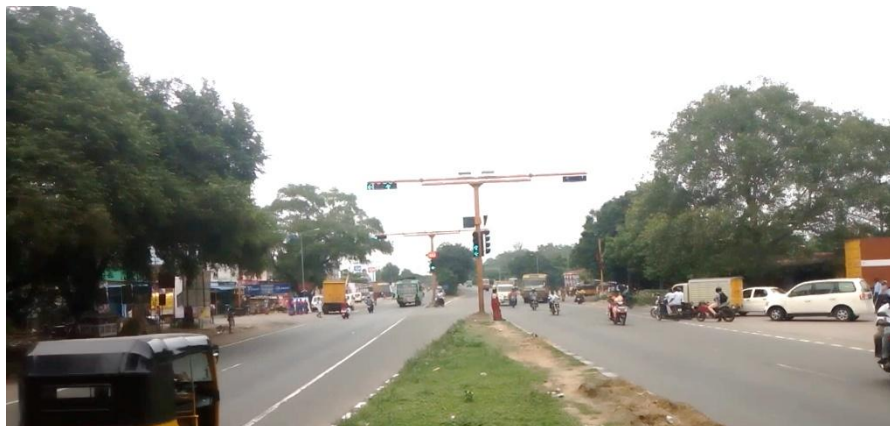
Figure 3: Photograph of Location

This junction has three major arms with a minor fourth arm with slightly staggered geometry. The town roads are connecting to NH-45 with a small offset and the eastern arm from Mahindra World City meets the NH at a skew. The junction is operating with a signal. Since no designated/marked crossing is available and with wide open area at the junction, pedestrians have difficulty crossing the NH and are exposed to high speed through traffic of NH. Mahindra world city, a significant traffic generator is located on eastern arm of the junction. There are commercial activities along the national highway approaches and also along the western side road of the junction. Bus bays with bus shelters are present on both sides of the NH on the northern arm of the junction.
